## Home Inspection Report

**829 Seabury Drive, San Jose**

**Ordered by: Jim Downey**  
J. Thomas Realty  
3268 Lynn Oaks Drive  
San Jose, CA 95117

**Johnny Saechao**  
March 10, 2017

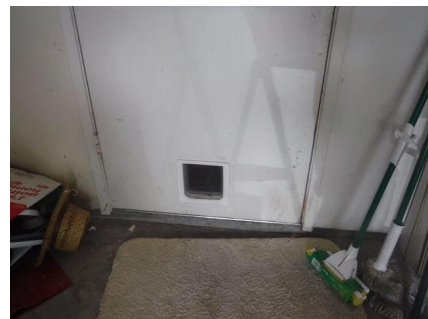
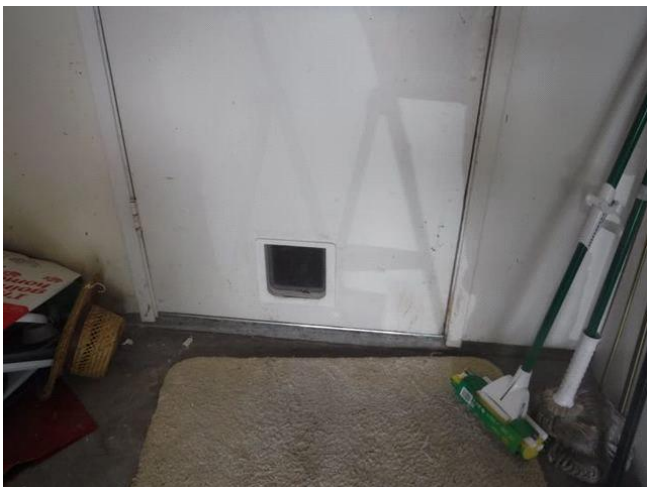
Photo 9

- ! 1. The pet door within the garage passage door is a breach in the fire separation between the garage and the living area. The opening is near the floor and may not significantly increase the risk of fire spreading. However, we recommend replacement of the passage door. (See Photo 9)

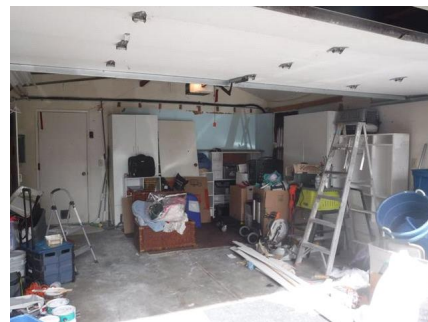
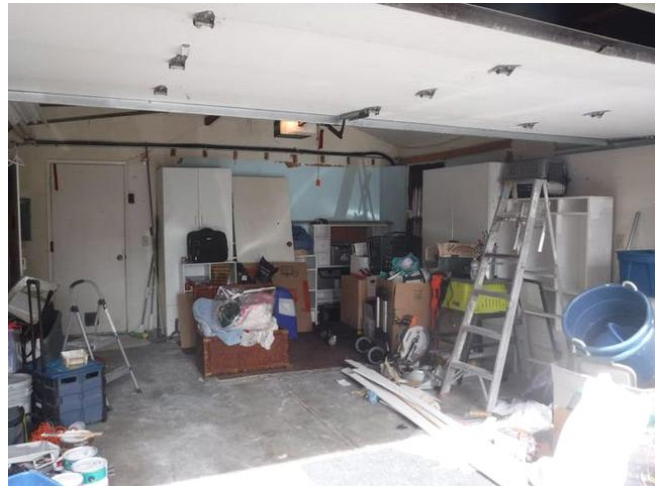
Photo 8

Personal storage was blocking access to the interior of the garage. Therefore, the area is considered inaccessible and was not fully inspected. With access and an opportunity for complete inspection, conditions in need of attention may be discovered. Ideally, the personal belongings should be removed so the area may be inspected. (See Photo 8)

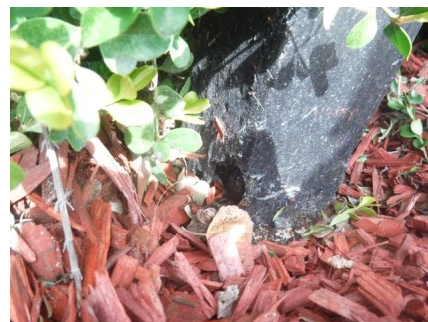
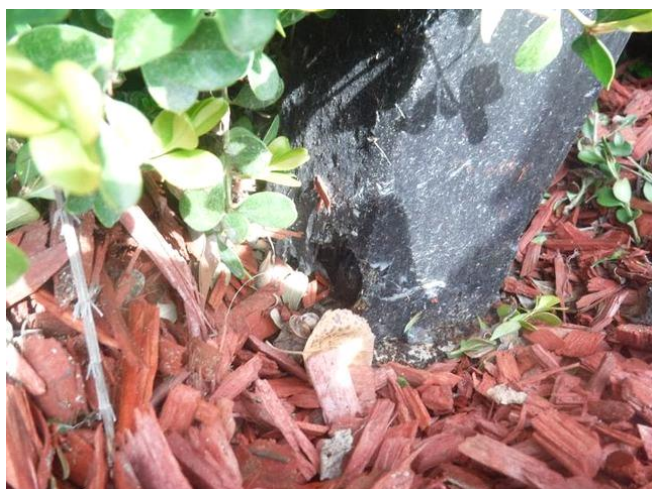
Photo 5

1. The pet door within the garage passage door is a breach in the fire separation between the garage and the living area. The opening is near the floor and may not significantly increase the risk of fire spreading. However, we recommend replacement of the passage door. (See Photo 9)
2. Personal storage was blocking access to the interior of the garage. Therefore, the area is considered inaccessible and was not fully inspected. With access and an opportunity for complete inspection, conditions in need of attention may be discovered. Ideally, the personal belongings should be removed so the area may be inspected. (See Photo 8)
3. The base of the support post(s) for the deck/porch cover or overhang are water damaged. We recommend the advice and services of licensed contractor and/or structural pest control company. (See Photo 5)

- ! 2. The base of the support post(s) for the deck/porch cover or overhang are water damaged. We recommend the advice and services of licensed contractor and/or structural pest control company. (See Photo 5)

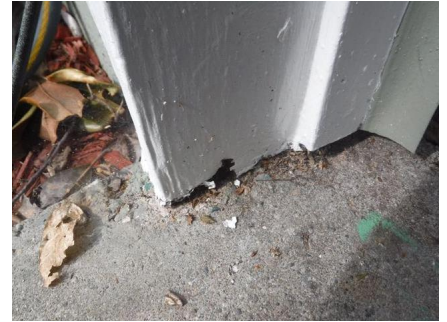
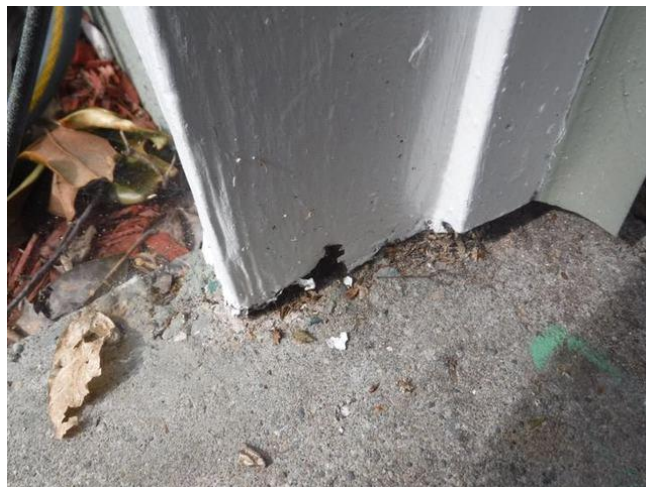
Photo 2

4. Water damage was observed to the exterior trim at the front. We recommend the services of a licensed general contractor and/or structural pest control company. (See Photo 2)

- ! 3. Water damage was observed to the exterior trim at the front. We recommend the services of a licensed general contractor and/or structural pest control company. (See Photo 2)

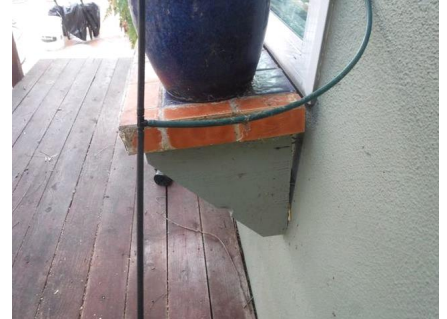
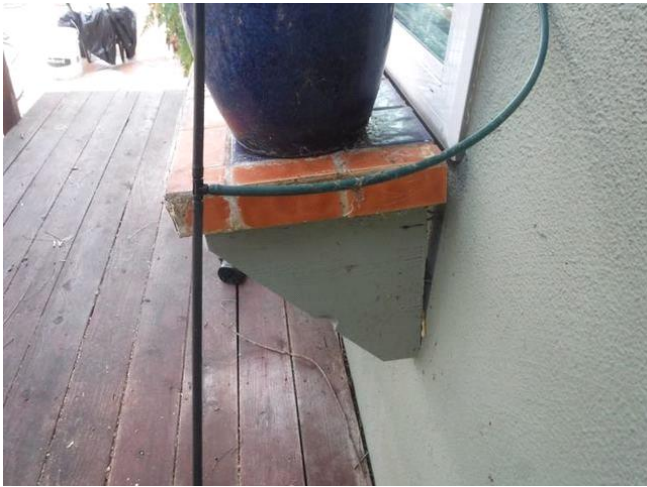
Photo 7

5. Damage was observed in the planter shelf. We recommend the advice and services of the appropriate trades regarding repairs to this area. (See Photo 7)

- ! 4. Damage was observed in the planter shelf. We recommend the advice and services of the appropriate trades regarding repairs to this area. (See Photo 7)

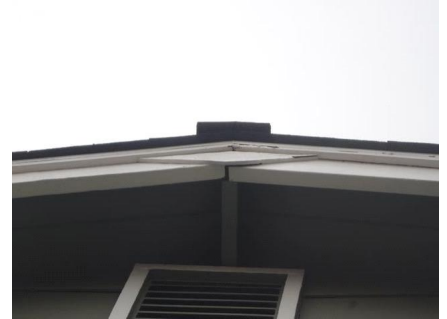
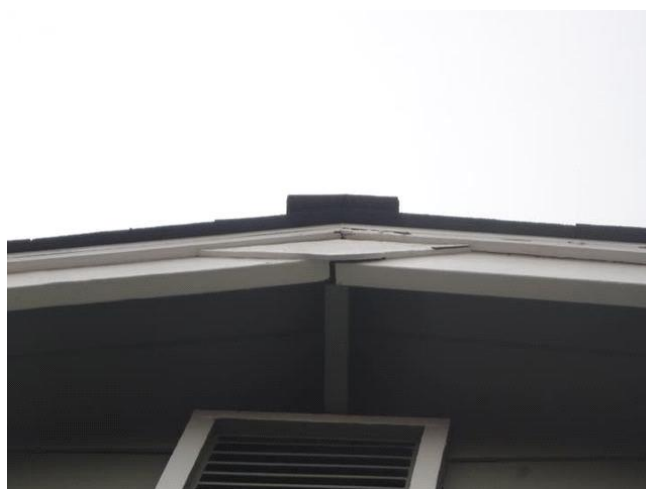
Photo 4

6. Damaged or cracked trim was noted at the right exterior. We recommend the trim be repaired or replaced. (See Photo 4)

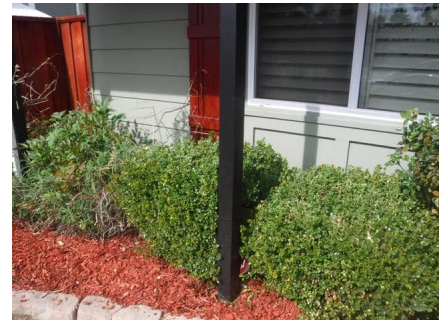
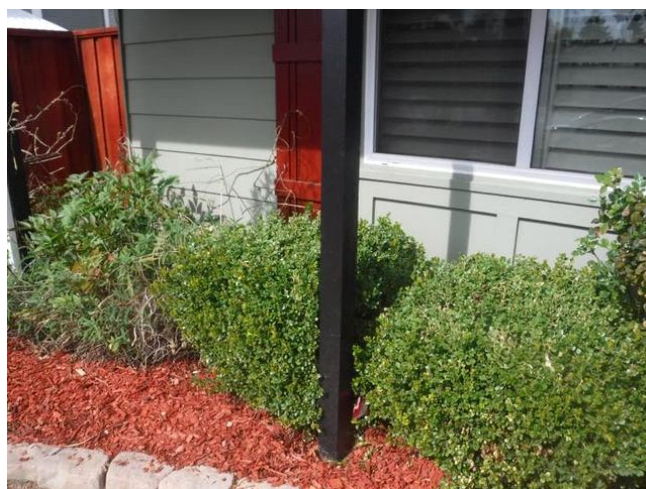
Photo 6

7. The patio cover is not adequately braced and is wobbly when pushed from side to side. We recommend the patio cover be strengthened to resist lateral movement. (See Photo 6)

- ! 5. Damaged or cracked trim was noted at the right exterior. We recommend the trim be repaired or replaced. (See Photo 4)
- ! 6. The patio cover is not adequately braced and is wobbly when pushed from side to side. We recommend the patio cover be strengthened to resist lateral movement. (See Photo 6)

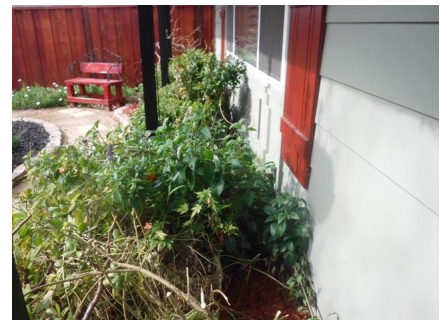
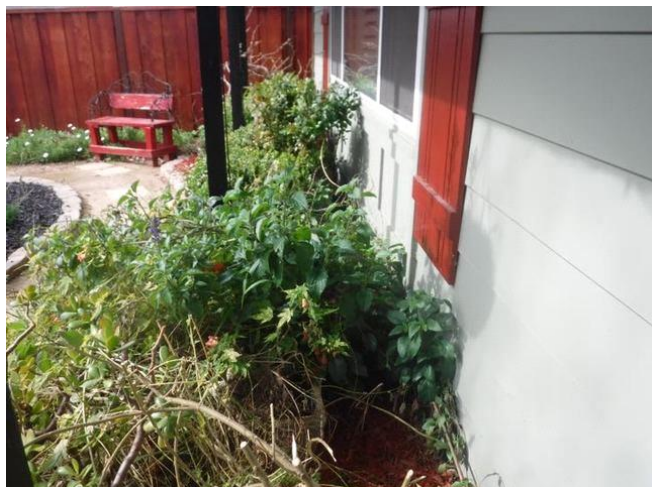
Photo 1

8. The side of the structure or property was inaccessible due to heavy foliage/vegetation. Reportable conditions may be hidden from inspection. We recommend this area be cleared to allow for further inspection. (See Photo 1)

The side of the structure or property was inaccessible due to heavy foliage/vegetation. Reportable conditions may be hidden from inspection. We recommend this area be cleared to allow for further inspection. (See Photo 1)

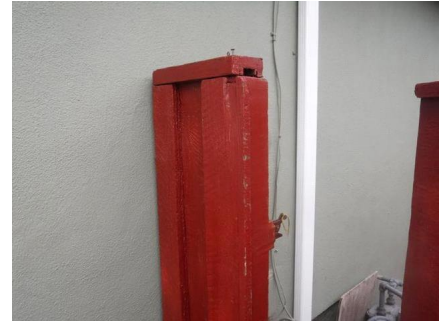
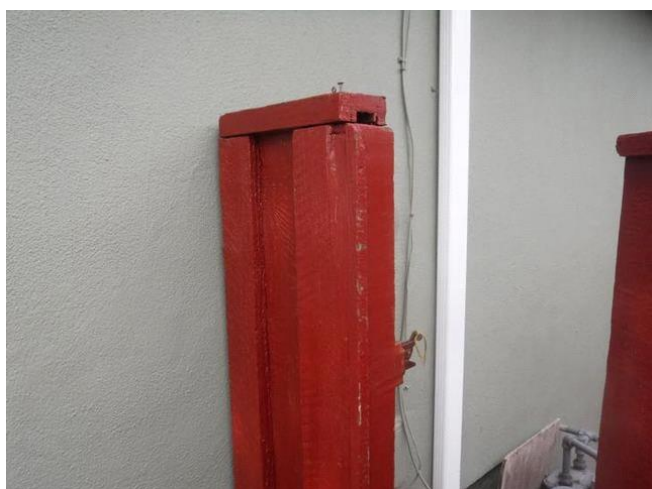
Photo 3

9. The fence is in satisfactory condition, however one or more of the fence posts are loose. We recommend all loose, damaged or deteriorated post be reinforced or replaced as necessary. (See Photo 3)

- ! 7. The fence is in satisfactory condition, however one or more of the fence posts are loose. We recommend all loose, damaged or deteriorated post be reinforced or replaced as necessary. (See Photo 3)

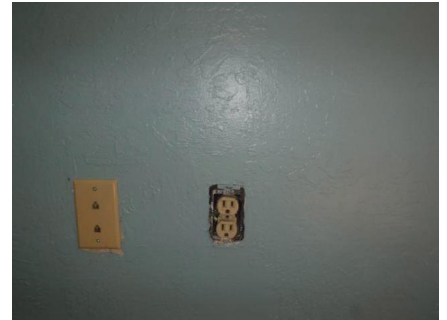
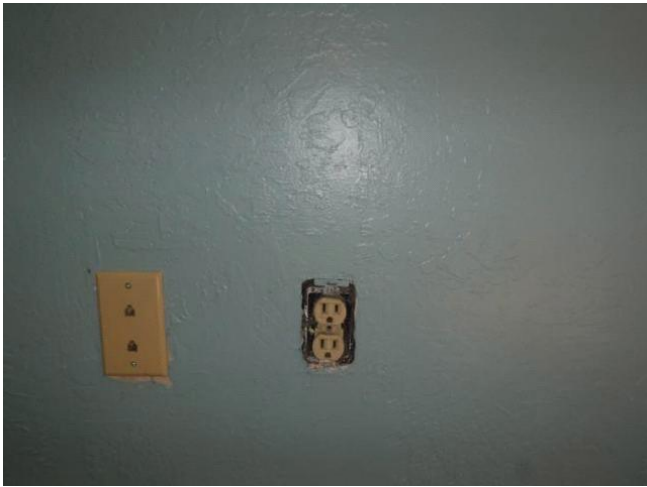
Photo 13

10. The missing outlet cover plates at the master bathroom should be replaced. Based upon our inspection of a representative number of outlets we recommend checking every outlet to make sure they all have covers. (See Photo 13)

- ! 1. The missing outlet cover plates at the master bathroom should be replaced. Based upon our inspection of a representative number of outlets we recommend checking every outlet to make sure they all have covers. (See Photo 13)

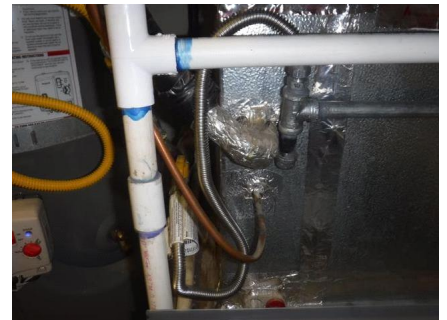
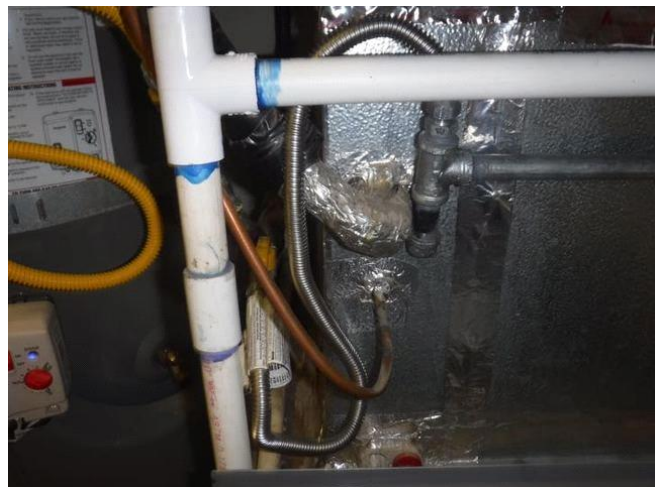
Photo 10

11. The gas connector for the furnace is aluminum tubing. This does not meet present standards. We recommend replacing the supply line with a flexible approved gas line meeting present standards. (See Photo 10)

- ! 1. The gas connector for the furnace is aluminum tubing. This does not meet present standards. We recommend replacing the supply line with a flexible approved gas line meeting present standards. (See Photo 10)
- 2. Some of the crawlspace heating ducts are in contact to the ground. This is conducive to corrosion and/or damage. We recommend a minimum of six inches of clearance be provided.

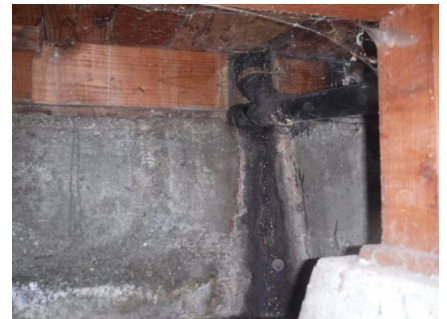
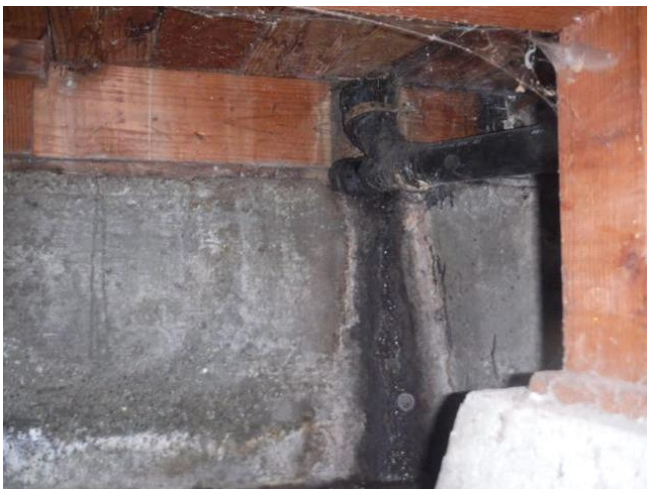
Photo 15

12. The kitchen sink drain is leaking into the crawl space. We recommend all leaks be repaired. (See Photo 15)

- ! 1. The kitchen sink drain is leaking into the crawl space. We recommend all leaks be repaired. (See Photo 15)
- 2. The installation of a gas pipe sediment trap at the water heater gas line should be considered.

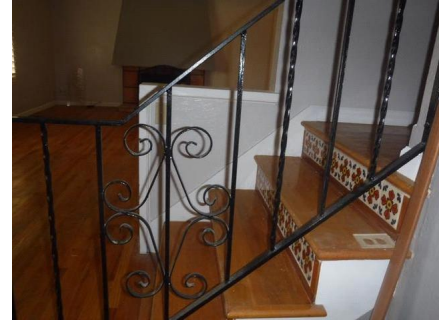
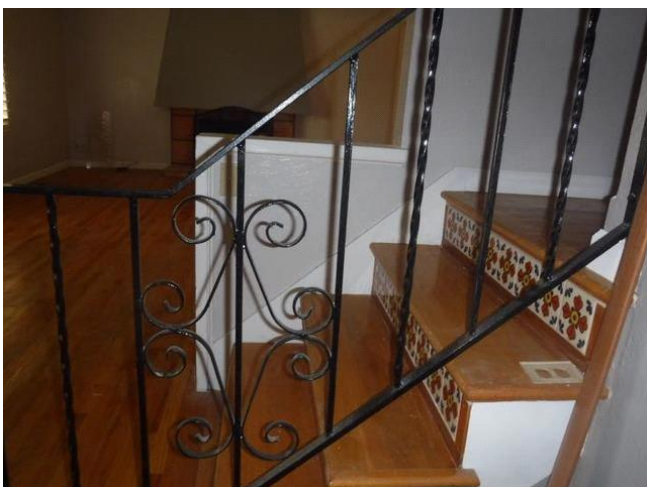
Photo 11

13. The openings in the railing are larger than 4". For improved safety it is recommended that the railing be altered for an opening of less than 4". (See Illustration 7B) (See Photo 11)

- ! 1. The openings in the railing are larger than 4". For improved safety it is recommended that the railing be altered for an opening of less than 4". (See Illustration 7B) (See Photo 11)

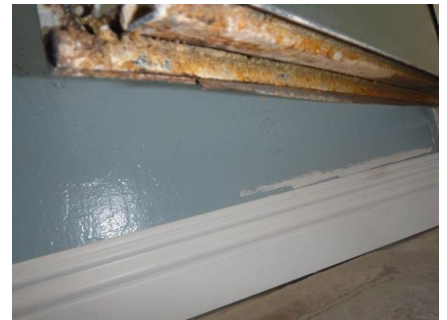
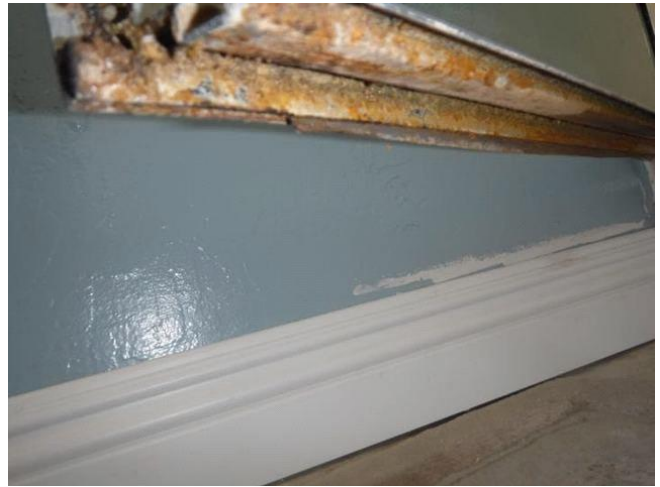
Photo 14

16. The tub/shower enclosure wiper seal at the master bathroom is faulty, missing and/or improperly installed. We recommend it be repaired or replaced. (See Photo 14)

- ! 9. The tub/shower enclosure wiper seal at the master bathroom is faulty, missing and/or improperly installed. We recommend it be repaired or replaced. (See Photo 14)
- 10. There were neither a glass shower/tub enclosure or a curtain in the upstairs hall bathroom. We recommend that the shower/tub not be used until the door or curtain has been installed.
- 11. A gap was noted at the escutcheons at the upstairs hall bathroom and master bathroom tub/shower faucet, spout or shower head. We recommend sealing this trim piece for a better appearance and to avoid leakage in this area.

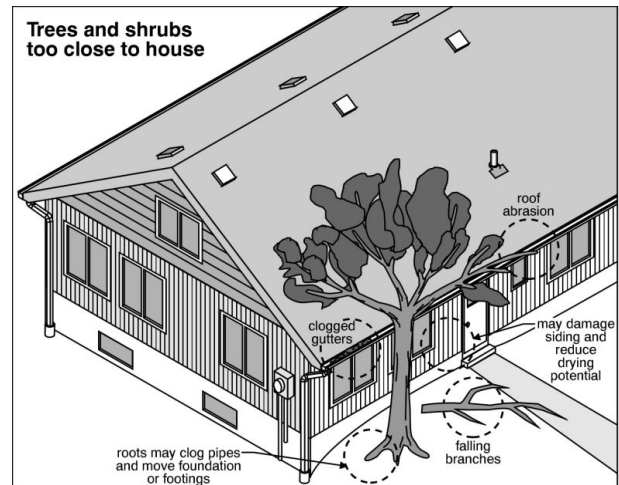
Illustration 8E

11. The driveway shows evidence of minor cracking. The cracks could be sealed for a better appearance and to prevent moisture intrusion.
12. The proximity of the tree at the wall could disrupt drainage pipes, cause mechanical damage to the exterior of the house or influence the foundation over time. For additional information and recommendations we recommend appropriate trades be consulted. (See Illustration 8E)
